# MPC5125 (M01S) Errata

by: Microcontroller Division

This document identifies implementation differences between the MPC5125, M01S (Rev. 1), and the processor's description contained in the *MPC5125 Microcontroller Reference Manual* and the *MPC5125 Microcontroller Data Sheet*. Refer to <http://www.freescale.com> for the latest updates.

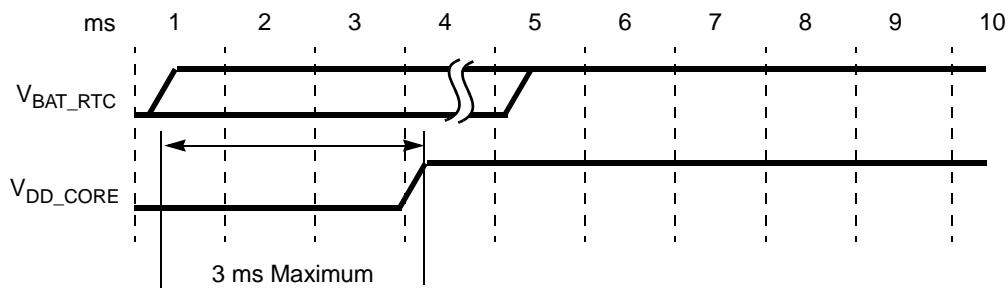
Figure 1.  $V_{\text{BAT\_RTC}}$  to  $V_{\text{DD\_CORE}}$  Timing

The Real-Time Clock (RTC) oscillator may not start properly when the  $V_{\text{BAT\_RTC}}$  power domain is active and  $V_{\text{DD\_CORE}}$  is transitioning from power-off to power-on.

When the  $V_{\text{BAT\_RTC}}$  power domain is active and the  $V_{\text{DD\_CORE}}$  transitions from off to on, the RTC time base becomes unreliable. The functionality of the oscillator and clock feeding the RTC counter is in one of three states:

Ensure that the  $V_{\text{BAT\_RTC}}$  power domain does not lead the  $V_{\text{DD\_CORE}}$  by more than 3 ms, or toggle  $V_{\text{BAT\_RTC}}$  after  $V_{\text{DD\_CORE}}$  has been turned on. The 3 ms is measured from  $V_{\text{BAT\_RTC}}$  at 50% to  $V_{\text{DD\_CORE}}$  at 90% of full values.

$V_{BAT\_RTC}$  can be powered concurrently with or enabled by  $V_{DD\_CORE}$ . Cycling  $V_{BAT\_RTC}$  power will result in the RTC counter being reset. See item 4 below. Following this workaround measure eliminates the need for measures 2 and 3 below.
