Errata to MPC8533E PowerQUICC™ III Integrated Host Processor Family Reference Manual, Rev. 1

This errata describes corrections to the *MPC8533E PowerQUICC™ III Integrated Host Processor Family Reference Manual*, Revision 1. For convenience, the section number and page number of the errata item in the reference manual are provided. Items in bold are new since the last revision of this document.

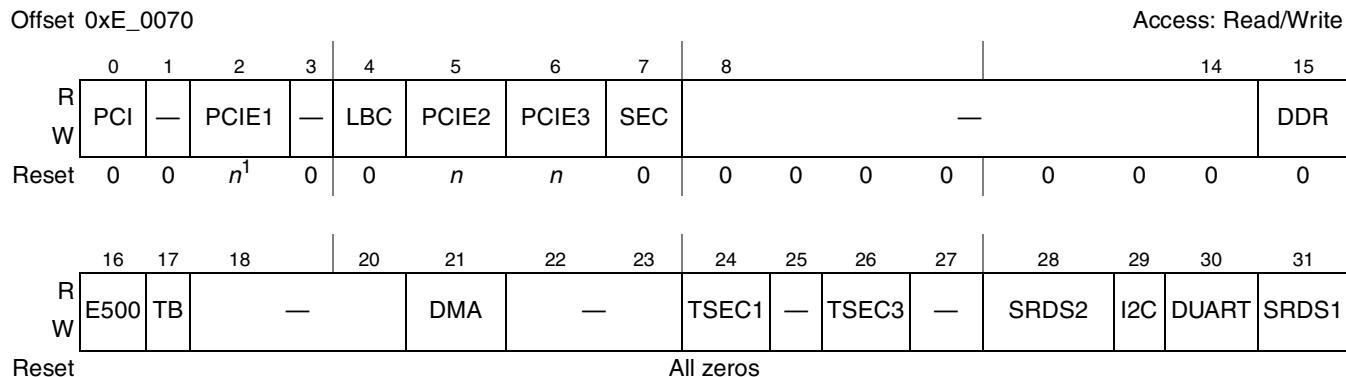
Figure 19-12. Device Disable Register (DEVDISR)

19.4.1.12, 19-14 Added fields SRDS2 and SRDS1 (bits 28 and 31) to Figure 19-12, “Device Disable Register (DEVDISR)” and Table 9-15, “DEVDISR Field Descriptions.” The register figure and field description table changes should appear as follows:

¹ * n bits depend on the state of the corresponding POR configuration signals at reset.
